Monthly Operating Report

June 2016

So. Sangamon

July 19, 2016

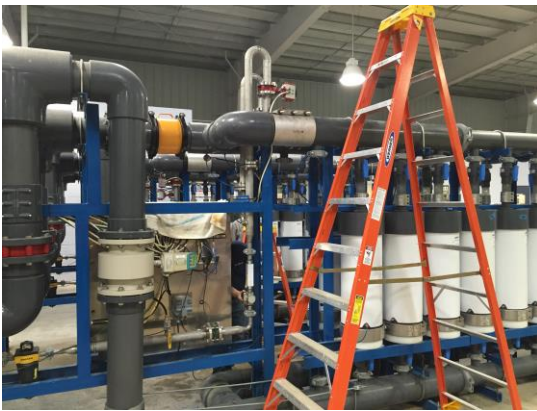
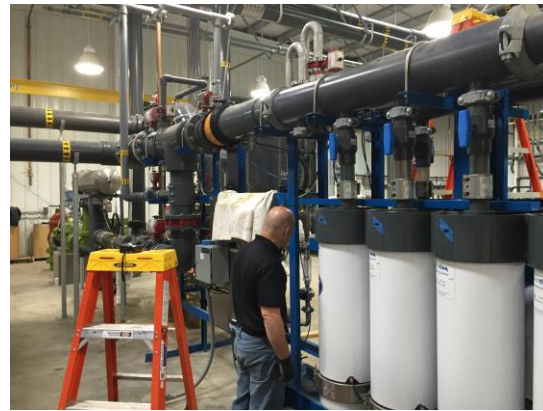
WesTech Engineering was on site May 31, June 1 and June 2, 2016. The main purpose of the site visit was to install pipe spools for the air scour line, pipe spools for the PDT line and install new air filter system. Other work accomplished during their visit was programming modifications to implement use of the new Neptune citric acid pump for CIP and maintenance cleaning, programming modifications for the VAF strainers to flush the higher pressure on Filter Banks 1 and 2, review alarm set points. Pictured below are pictures taken while the work was in progress.

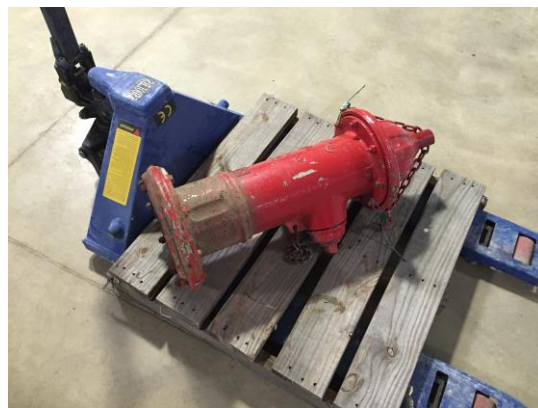
The fire hydrant at the corner of Old Route 54 and Loami Bates Road has been damaged. Dan Held and Keith Sommers picked up the hydrant and brought it back to the plant. We will schedule repairs to the hydrant as soon as possible. Pictured below is the hydrant to be repaired.

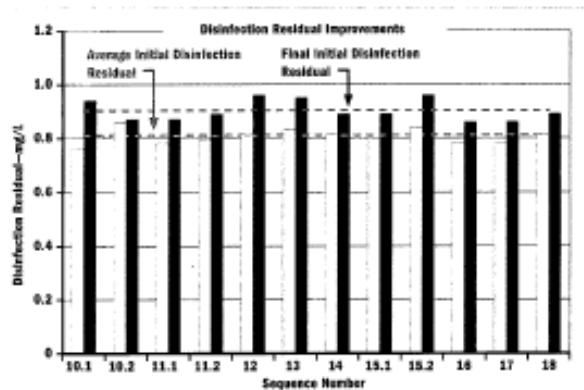
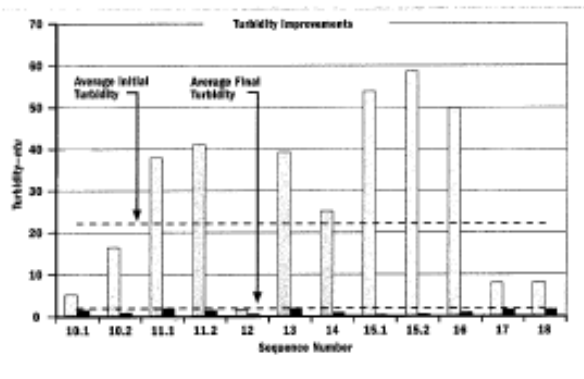
Disinfection residual and turbidity improvements were measured in a recent unidirectional flushing (UDF) pilot program at a water system in Northern California. As illustrated in the figures below, the initial chlorine residual was consistently low before each flushing sequence and inconsistent. However, at the UDF sequence's completion, the final residual was more stable and, in most cases, actually increased after all flushing sequences were completed.

The results were similar for the water turbidity in each of the sequences. As shown, once the flushing of the sequences began, the turbidity decreased significantly and dropped as much as 20 nephelometric turbidity units on average. These results immediately validated the success of using UDF for this particular agency.
